## EQUIPMENT REPAIR REPORT

**Our Reference:** 5000011888

**Description:** Vertical turbine, less driver (500 hp 575 v US Electric in a 5009PH frame).

**Model:** VIT FF 20 EHC

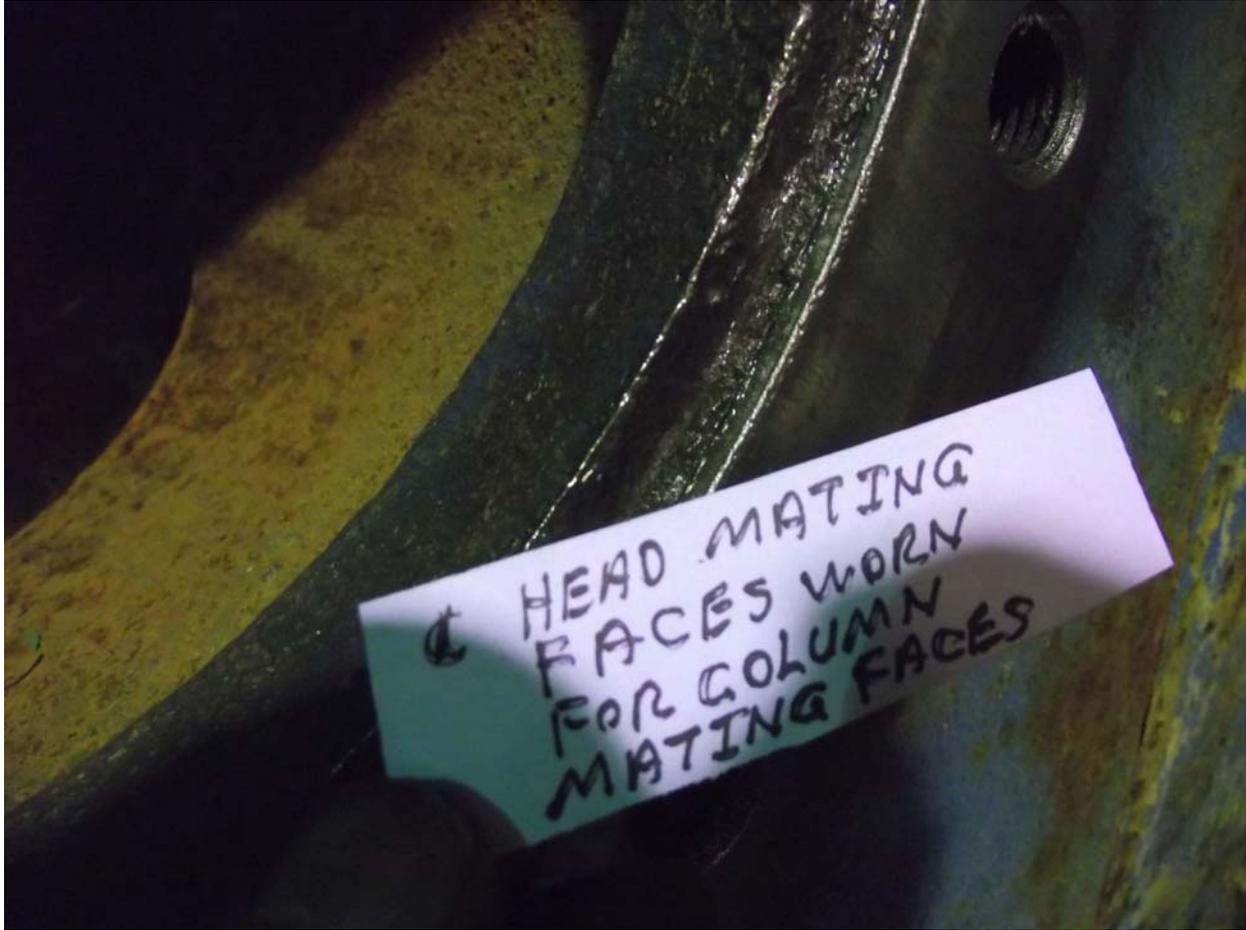
We found that the top column to head fit was 0.041" loose. This is too loose and could result in shaft binding. In order to bring this fit back into tolerance we will weld repair the column and machine the head inner diameter.

Ⓒ HEAD MATING  
FACES WORN  
FOR COLUMN  
MATING FACES

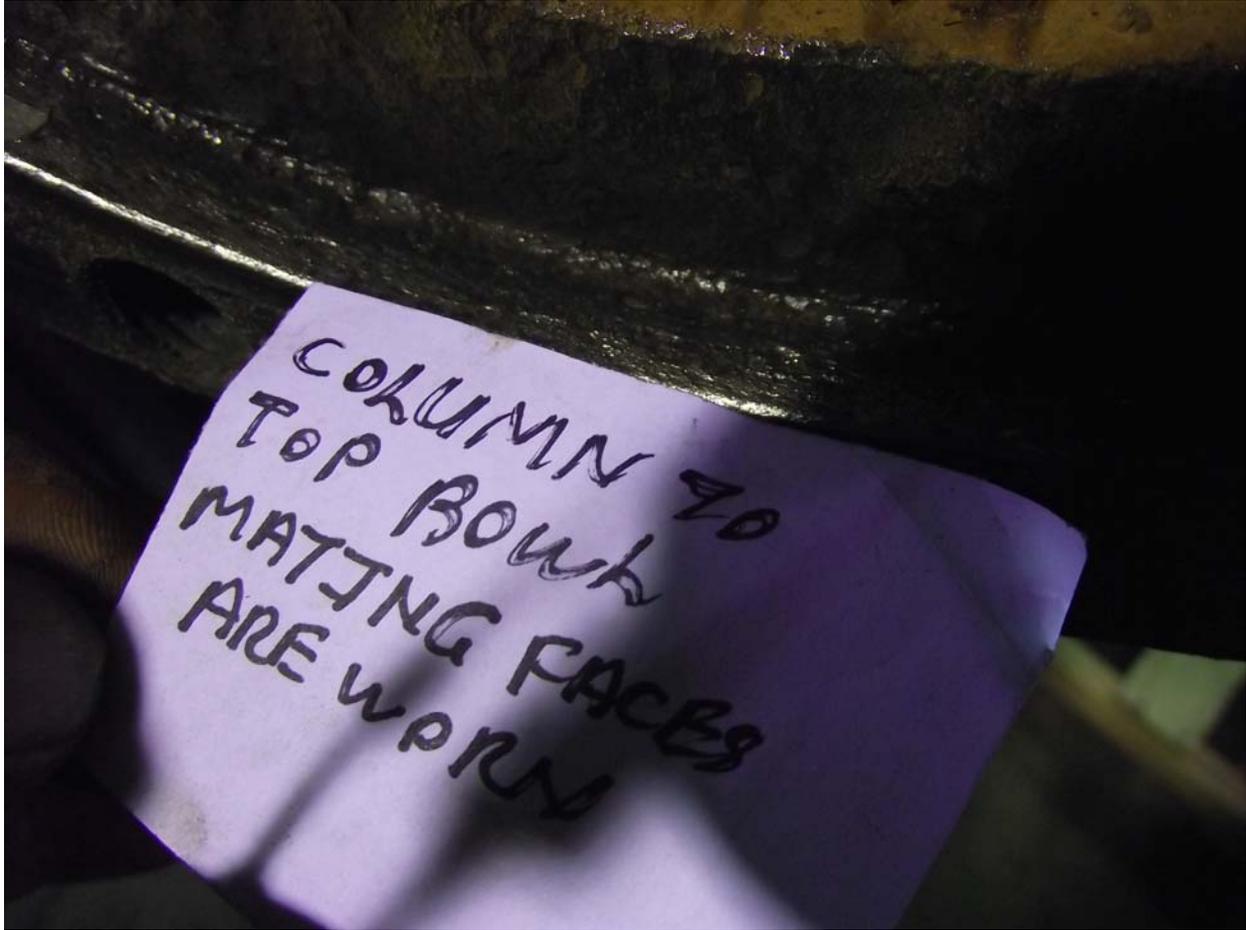
The top bowl to bottom column fit is 0.031" loose. This is too loose and could result in shaft binding. In order to bring this fit back into tolerance we will weld repair the column and machine the bowl spigot outer diameter.

COLUMN 70  
TOP BOWK  
MATING FACES  
ARE WORK

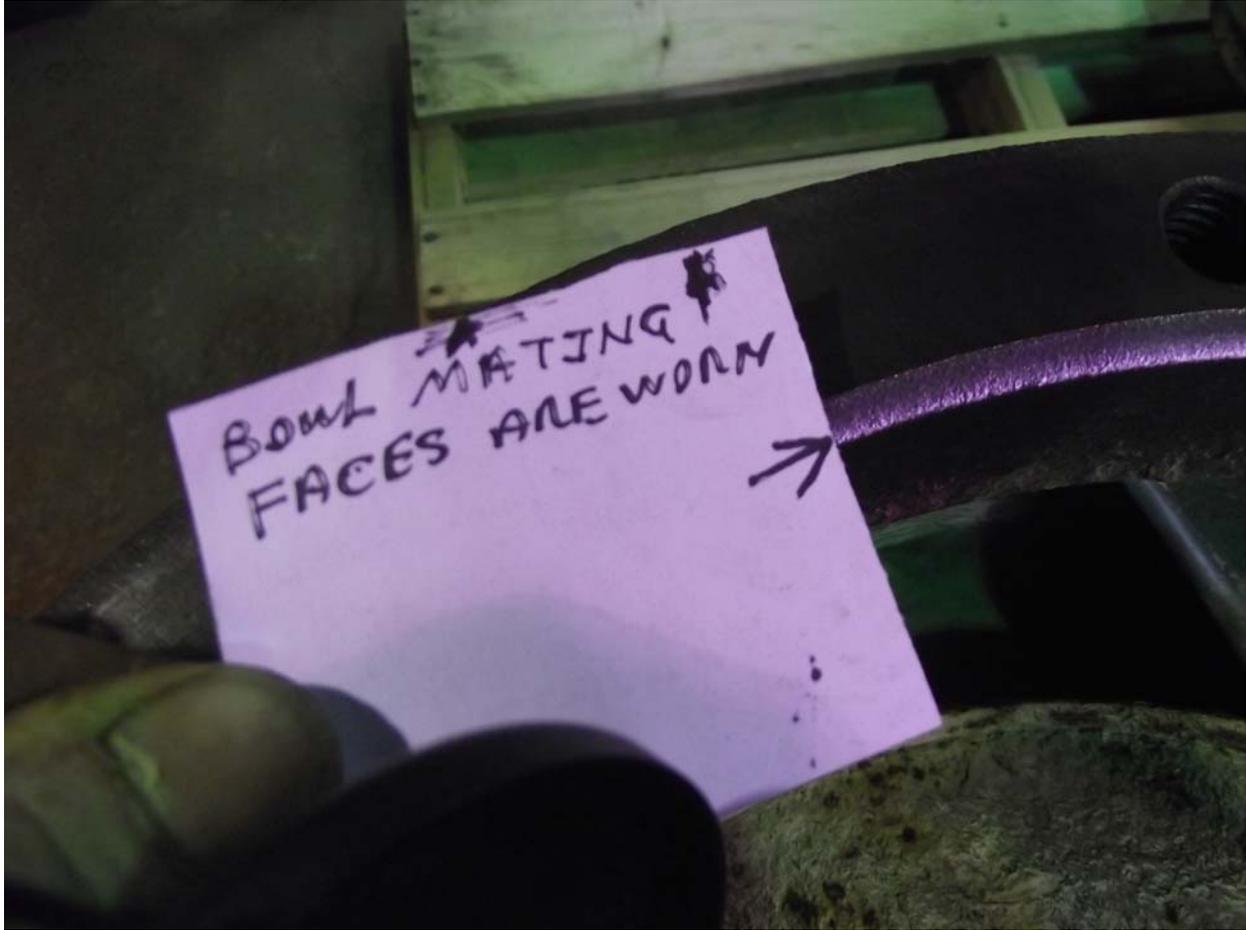
BOWL MATING  
FACES ARE WORN

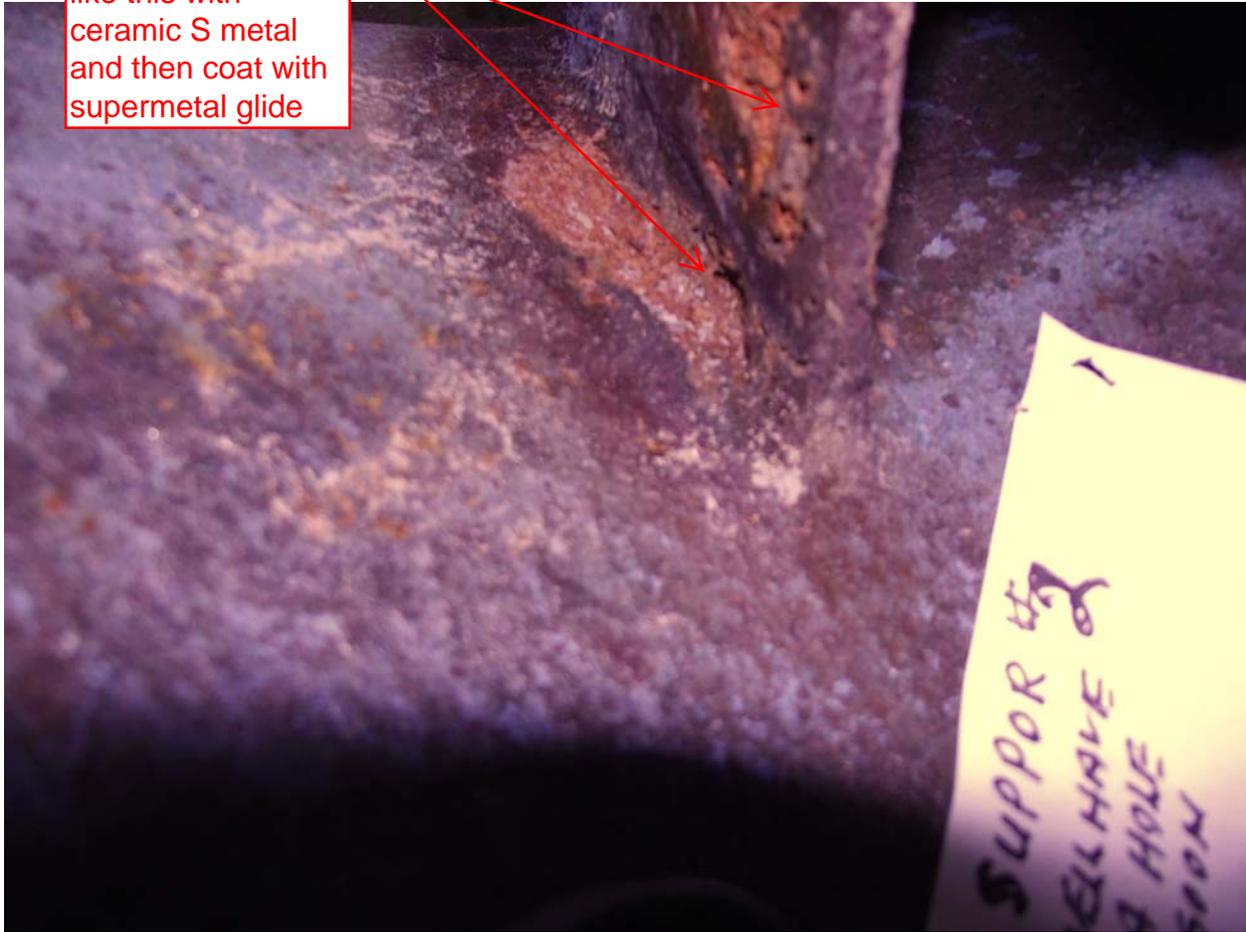
The bowls and the suction bell are lined with vitraglass / herisite coated (green coating) at the factory. As we mentioned in previous years this coating was wearing away. As can be seen in the photo below the web in the suction bell is eroding. We will grit blast and build up the eroded area of the suction bell with Belzona Ceramic S metal and then coat with Belzona Super Metal Glide coat in order to preserve the remaining cast iron.

we will repair areas like this with ceramic S metal and then coat with supermetal glide

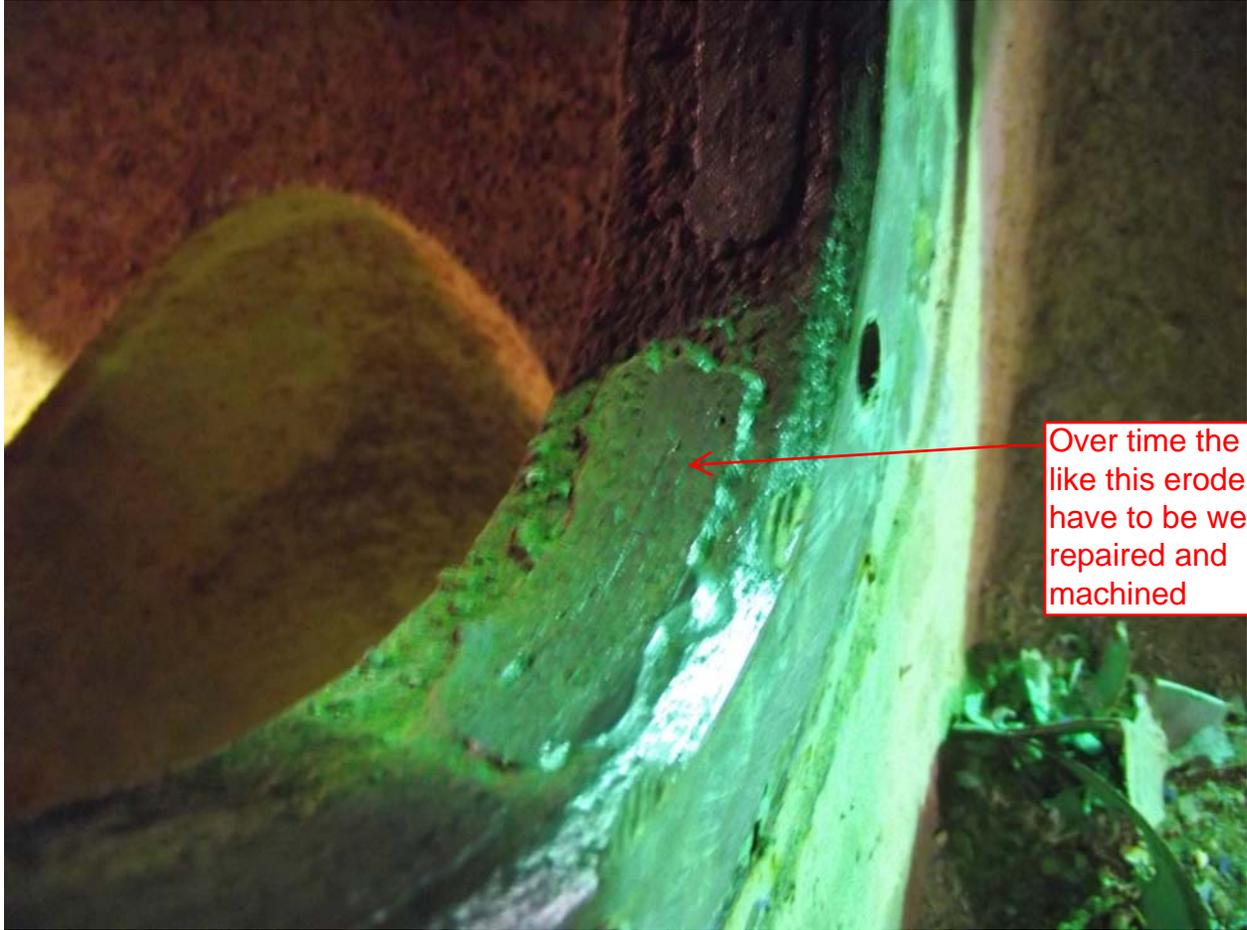
Over time the fits like this erode and have to be weld repaired and machined

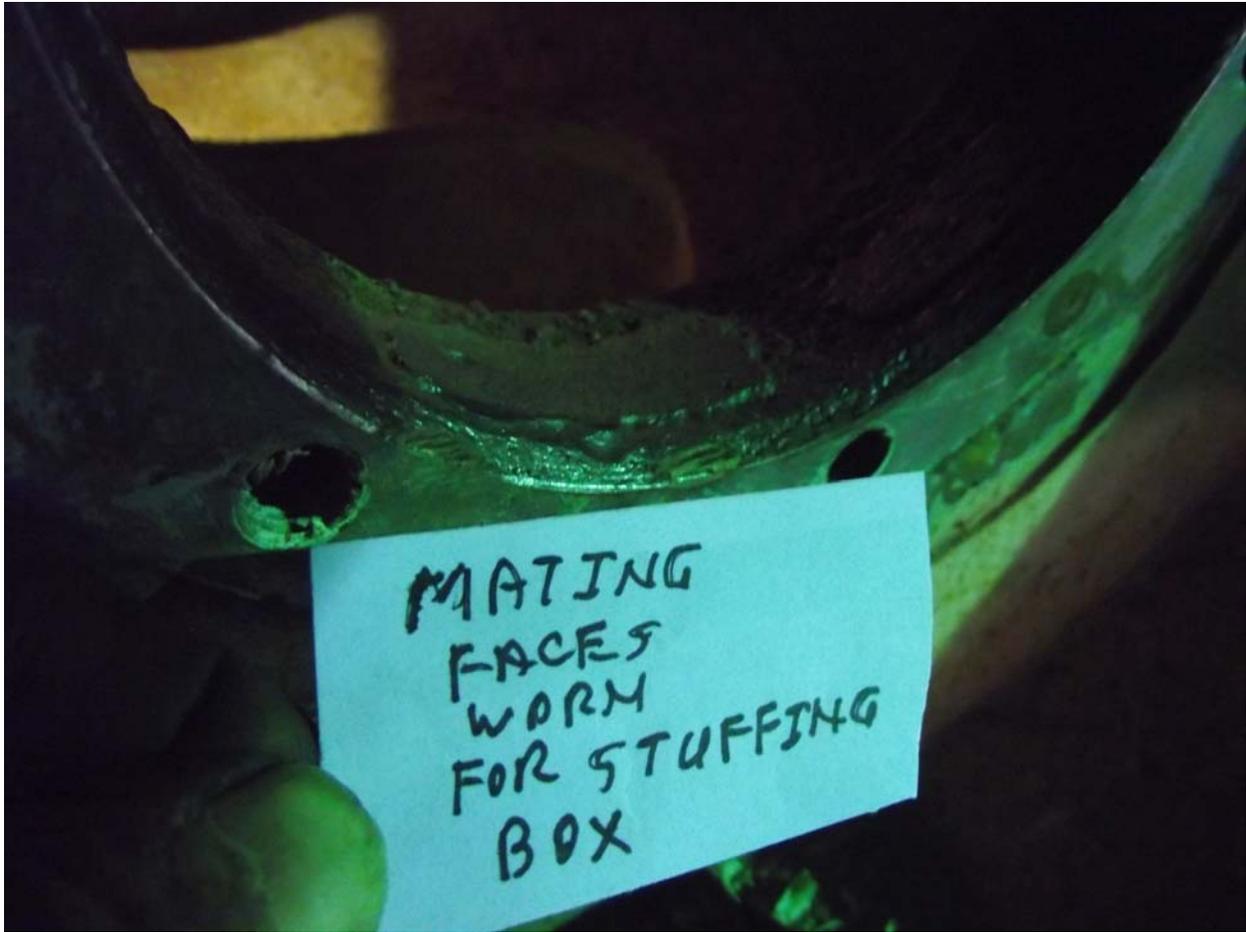
The stuffing box (616) has also suffered from erosion to the point that the registered fit has been compromised. Last year the stuffing box was replaced and the fit was repaired. The repair to the fit in the head has eroded but it is acceptable. Next year this fit will require welding and machining.

The line/column shaft (648) was checked for straightness and is within the acceptable tolerance with the average total run out less than 0.0005” T.I.R. per foot and never exceeding 0.005” T.I.R. over the length of shafting. As can be seen from the photos the shaft is worn at the location of the packing. It is also worn at the shaft bearing. The year before last year we chromed the shaft at the locations that were worn. Last year we were able to invert the shaft end for end exposing a new shaft area to the bearing and packing, no chroming was required last year. This year we will machine and chrome the again to bring the shaft back to within the required tolerance.

MATING  
FACES  
WORM  
FOR STUFFING  
BOX

COLUMN SHAFT  
WORN BY PACKING

This shaft will be  
machined,  
chromed and  
ground
