EQUIPMENT REPAIR REPORT

Our Reference: Sales Order #5000005109

Your Reference: Spindle Oil Pump

Subject: Gould's 3196 1x2-10

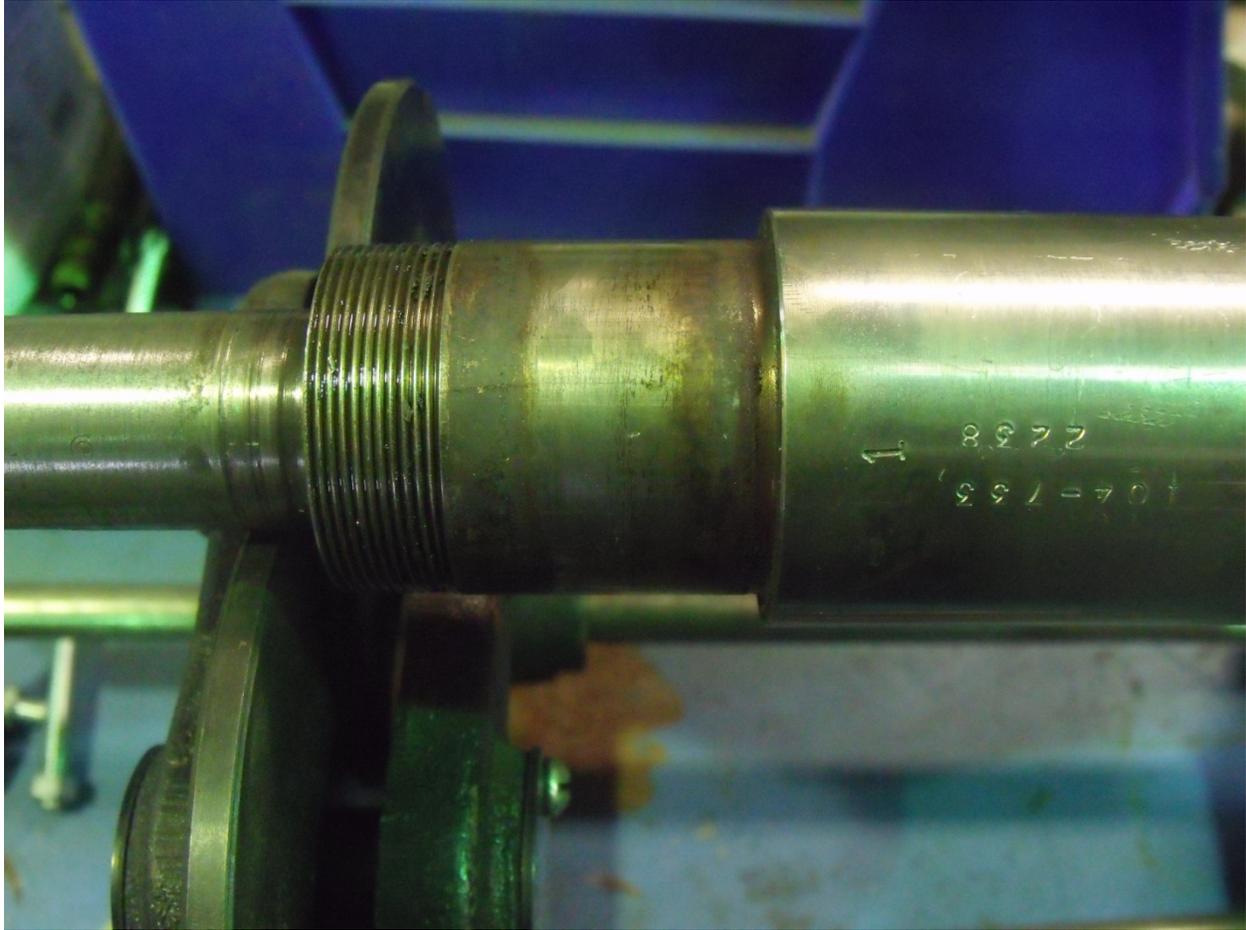
The shaft was found in good condition. We checked the shaft for grooves and pitting. We checked the shaft for straightness and for bearing fits. All were in accordance with the attached table and the shaft is okay for re/use.

The shaft is in good condition see shaft tolerance p for details registered fits measure within manufactures tolerances and the shaft has no indication of grooving or evidence of extensive wear.

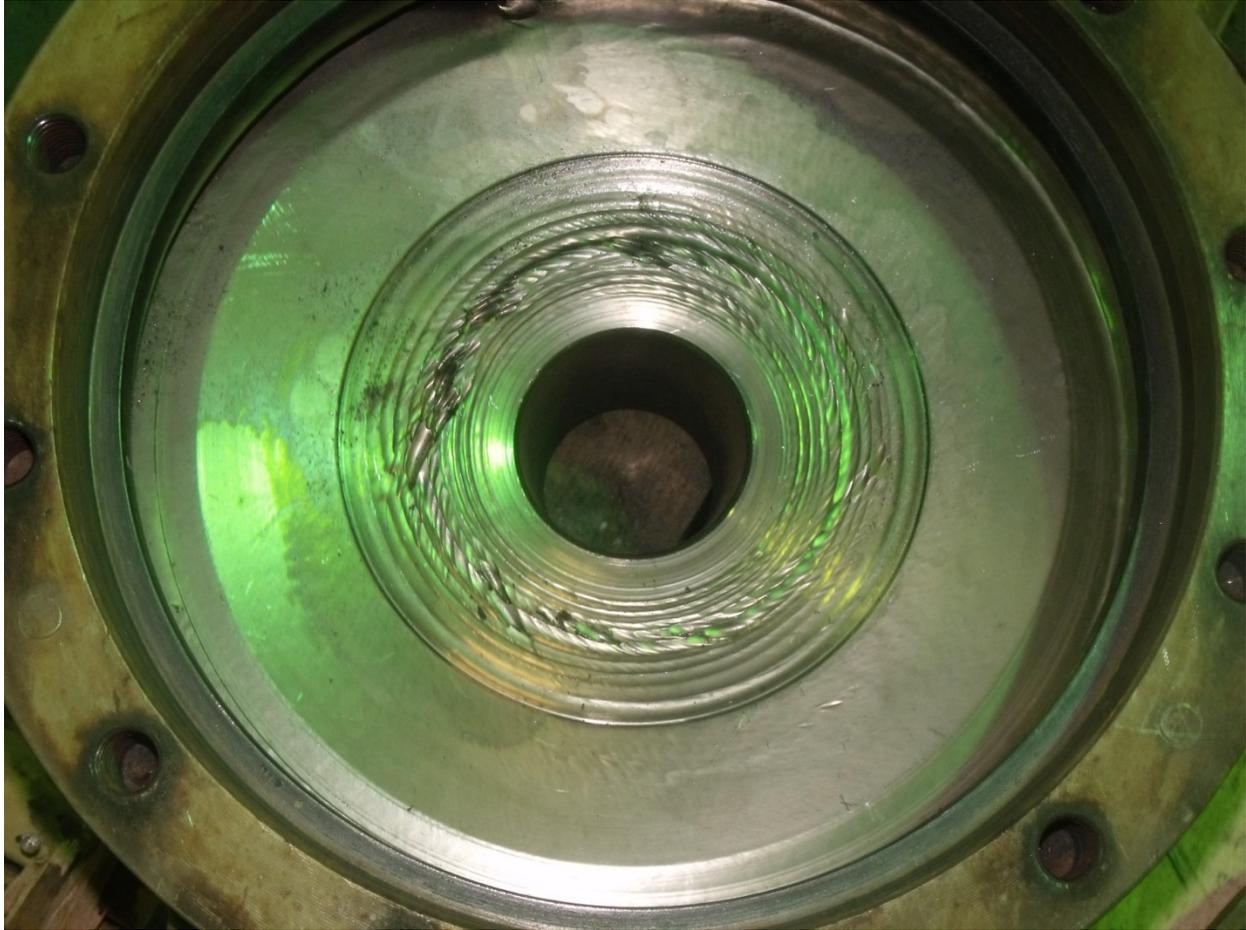
Upon further investigation of the pump we found the casing as received, showing extensive damage due to erosion-corrosion. The gouging is 1/4" deep in some areas. It is likely that the fluid

is mostly free of large abrasive particles. The damage was most probably caused by a combination of abrasion from very small particles and a high fluid velocity and flow turbulence due to casing surface imperfections, discontinuity and pump operation at a very low flow causing extensive recirculation. The casing may have also suffered from the effects of the impeller contacting the casing while in operation. The casing can be weld repaired but the amount of welding required is extensive and the casing would require a complete re-machining to ensure all of the surfaces are true. Casing replacement is recommended. With the replacement of the casing and impeller the pump hydraulics will once again be in accordance with what was originally supplied.

The casing as received is showing extensive damage due to erosion-corrosion. The gouging is $\frac{1}{4}$ " deep in some areas. It is likely that the fluid is mostly free of large abrasive particles. The damage was most probably caused by a combination of high fluid velocity and flow turbulence due to casing surface imperfections and discontinuity as well as the effects of the impeller contacting the casing while in operation.

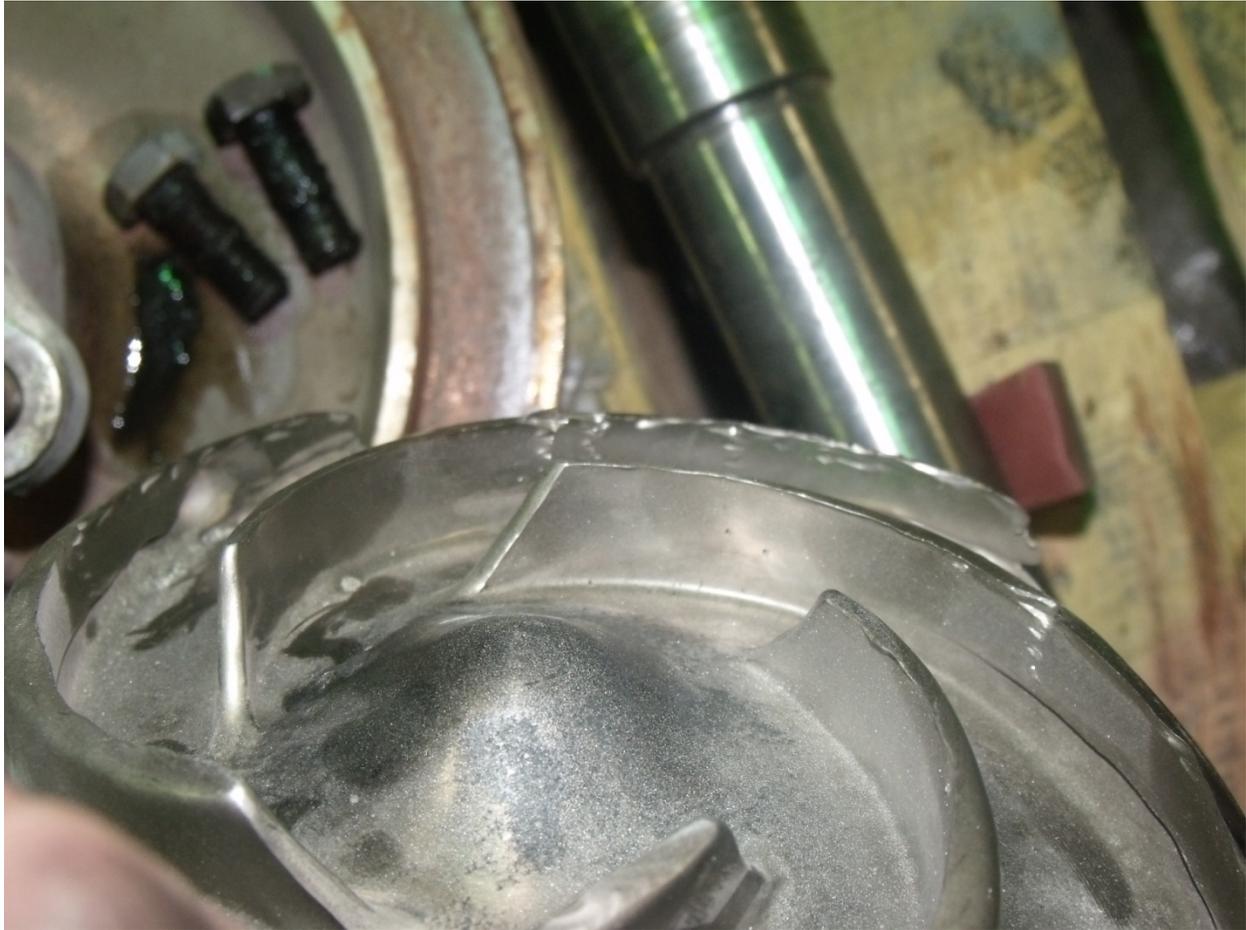
The impeller shows evidence of erosion with the vanes worn thin and smooth. The inside of the vanes have small channels running the length of the vane. This is caused by the same erosion that is occurring in the casing. This impeller also shows signs of an impact with the casing where there is evidence of matching marks. This impeller would require extensive welding and machining. It is more economical to replace the impeller than it is to repair it.

The impeller shows evidence of erosion. The inside of the vanes have small channels running the length of the vane, this is caused by the same erosion that is occurring in the casing. This impeller also shows signs of an impact most likely with the casing where there is evidence matching the marks on the impeller. This impeller would require extensive welding and machining. It is more economical to replace the impeller than it is to repair it.

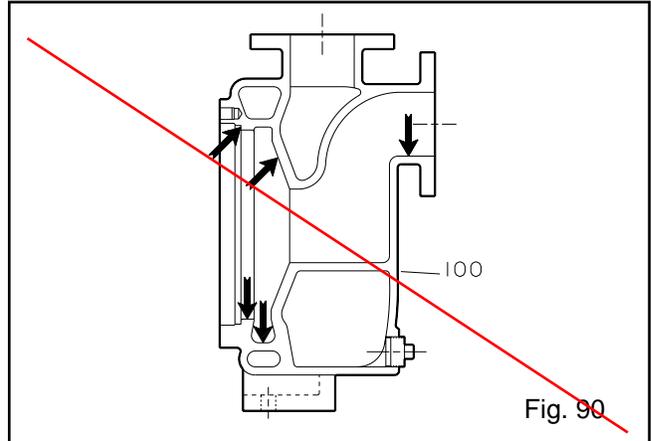
Fig. 90

The cut water is eroded

Severe wear (see photos). wear greater than 1/8" deep

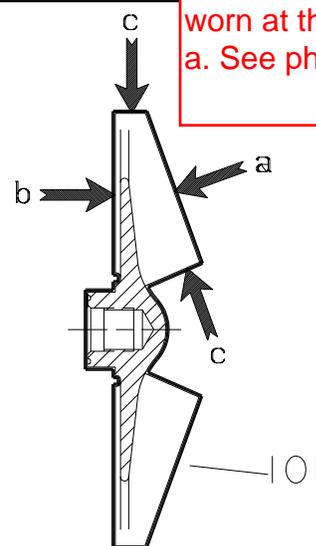
Fig. 91

The impeller is severely worn at the locations c and a. See photo

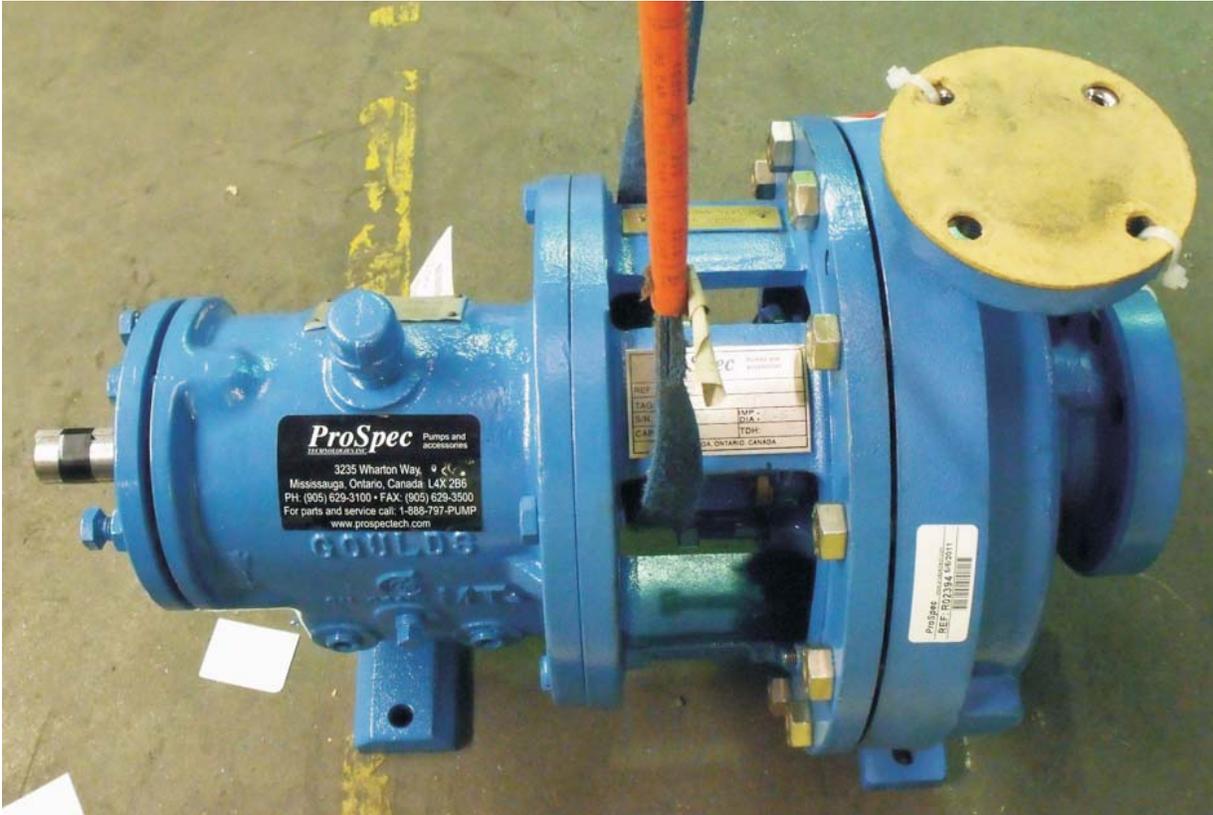
Completed repair at shipping.
