EQUIPMENT REPAIR REPORT

Our Reference: Sales Order #5000005109

Your Reference: Spindle Oil Pump

Subject: Gould's 3196 1x2-10

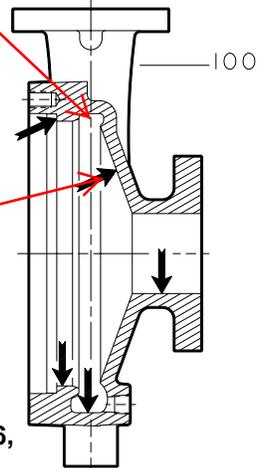
Fig. 88

The casing as received is showing extensive damage due to erosion-corrosion. The gouging is $\frac{1}{4}$ " deep in some areas. It is likely that the fluid is mostly free of large abrasive particles. The damage was most probably caused by a combination of high fluid velocity and flow turbulence due to casing surface imperfections and discontinuity as well as the effects of the impeller contacting the casing while in operation.

Severe wear (see photos). wear greater than 1/8" deep

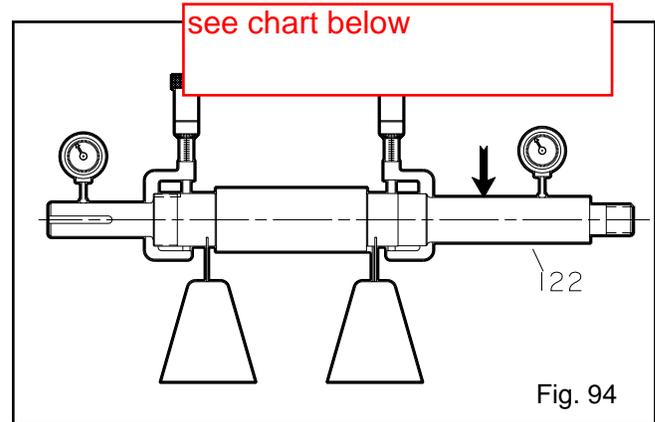
Fig. 94

The shaft is in good condition see shaft tolerance p for details registered fits measure within manufactures tolerances and the shaft has no indication of grooving or evidence of extensive wear.

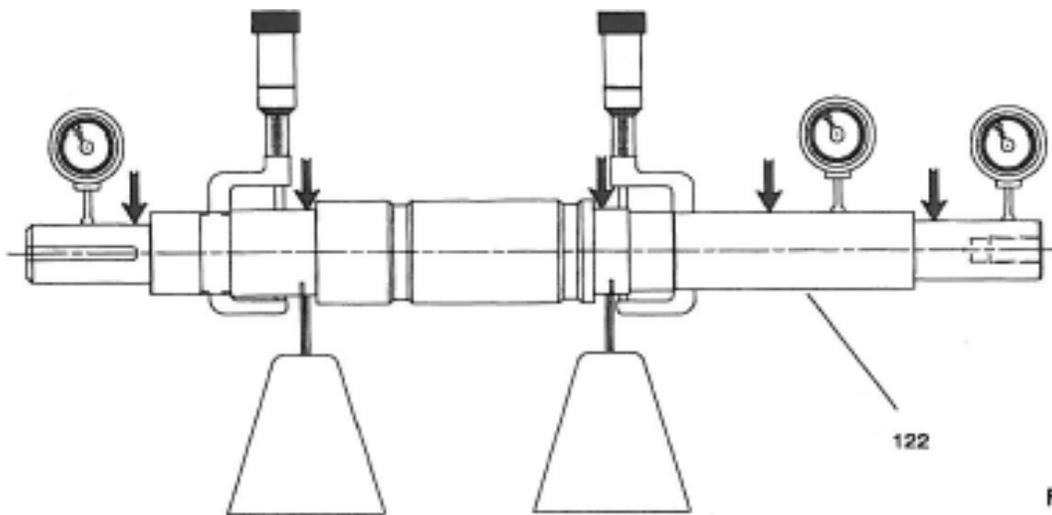
Fig. 33

Completed repair at shipping.
